Product inspection equipment delivers patty perfection

by Russell Morgan,
Product Inspection Specialist,
Mettler-Toledo, UK.
www.mt.com/pi

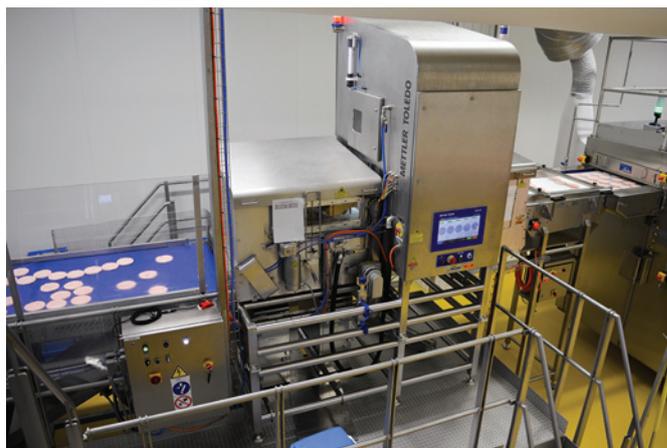
Bell Food Group is producing perfect burger patties using a new X39 x-ray inspection solution from Mettler-Toledo that checks for contaminants and defects.

The X39 has a two-stage inspection process that enables meat product manufacturers to deliver the highest levels of product consistency and quality with a single machine. The first stage uses integrated laser technology that determines conformity with pre-programmed

product parameters for length, width and height, as well as checking for any flake defects. Non-conforming products are rejected, while good product continues to the second integrity check.

The second check uses an x-ray detector to inspect the remaining good product for foreign-body contaminants such as calcified bone, mineral stone, glass, metal and high-

density plastic; while simultaneously checking for holes, dents and edge defects, plus any anomalies in mass and shape.

At each stage reject nozzles, using jets of air, accurately target and remove non-conforming products down a gap between consecutive conveyors into a primary rework bin for high accuracy sorting. If the product is too large to fit in the gap – for example two patties joined together – a rejection flap will automatically remove the item.

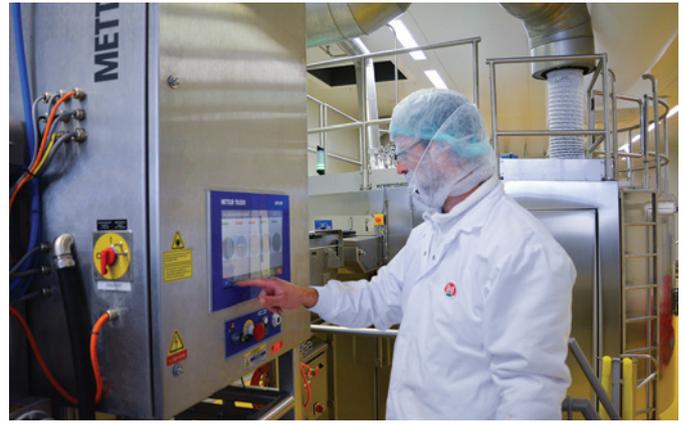
Integrated software enables product parameters to be stored for quick changeover and reasons for rejection to be analysed, with quality indicators passed on to customers.

For maximum operational efficiency, the X39 is equipped with advanced software that makes the system very simple to operate and is designed to ensure that the technology is always fully optimised. Product changeovers are very quick because menus can be stored, reducing human error. The software monitors all aspects of the system and provides pre-warnings of the accuracy of the lasers, reject nozzles and reject confirmation sensors. In addition, the technology records and collects all inspection results for due diligence and food safety legislation requirements.

"Thanks to the X39, we can first define and save the tolerance parameters for individual reasons for rejection," added Ueli. "Then we can get an extremely detailed picture of how many patties were rejected as the result of foreign bodies, such as bone and cartilage, or as the result of visual defects.

"An image of each individual rejected patty is saved in the image library so that we can analyse exactly where and how the problems occurred. In my opinion, the combination of all these capabilities in one system is far more than other providers can offer."
