Solutions to physical contamination challenges in meat production

by Russell Morgan,
Mettler-Toledo.
www.mt.com

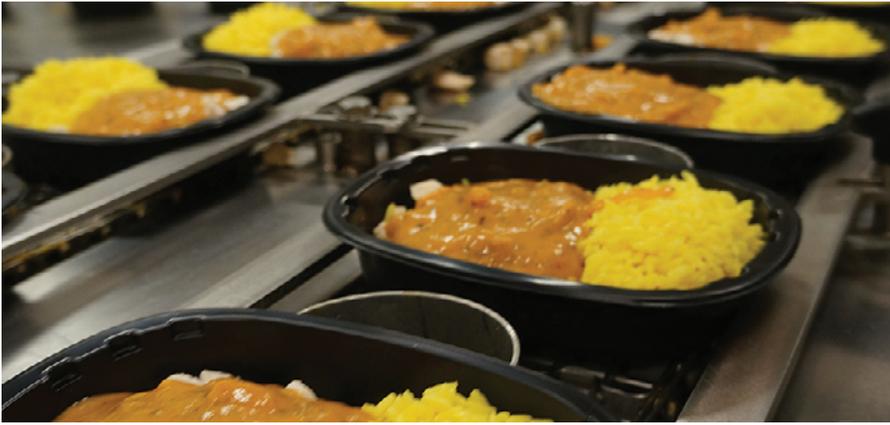
Advancements in product inspection technology ensure that contaminants in challenging applications, such as ready meals, can be detected reliably.

Advancements in contaminant detection technology ensure that both x-ray and metal detection systems have high sensitivity levels to detect small contaminants in challenging applications. Some metal detectors utilise multiple frequencies simultaneously to cancel out the signal in 'wet' products like

Continued from page 11
raw meat. Meanwhile, advanced x-ray systems automatically adjust the amount of power needed to maximise the image contrast according to the product being inspected.

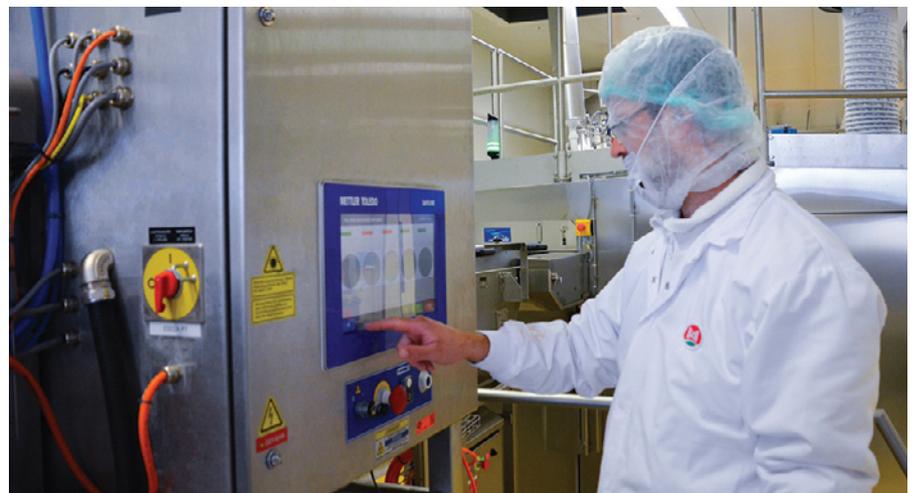
Software innovation has enabled both x-ray systems and metal detectors to offer semi- or fully-automated product set-up routines that reduce human error and false reject rates.

Software innovation has enabled both x-ray systems and metal detectors to offer semi- or fully-automated product set-up routines. By reducing the possibility of human set-up

errors, detection sensitivity levels are maximised: thereby reducing false reject rates and saving associated waste costs.
